NUMBER: 18-002-04

Flash: Erroneous Diagnostic Trouble Codes (DTC's) P0335 or P0340 Crankshaft or Camshaft Position Lost

2004 (DR) Ram Truck

NOTE: This bulletin applies to DR vehicles equipped with a 5.7L engine (sales code EZA) built on or before December 16, 2003 (MDH1216XX).

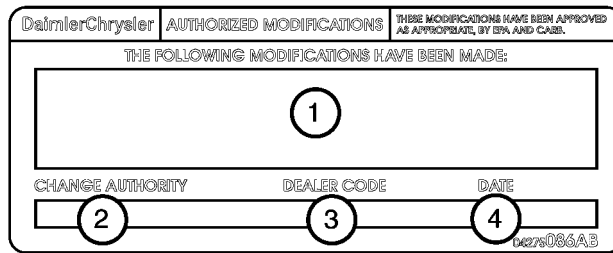
FIGURE 1 - AUTHORIZED MODIFICATION LABEL

1-	POWERTRAIN CONTROL MODULE P/N (INSERT P/N) USED
2-	CHANGE AUTHORITY: TSB XX-XXX-XX
3-	DEALER CODE: XXXXX
4-	DATE: XX-XX-XX

26. Type the necessary information on the "Authorized Modification Label" p/n 04275086AB and attach near the VECI label (Figure 1).
